An Assessment of Ramp Designs as Barrier-Free Accesses in Public Buildings in Abuja, Nigeria

Anunobi Anthony Ikechukwu, Adedayo Olatunde Folaranmi, Ayuba Philip, Oyetola Stephen Ayodele, Otijele Godwin Omachoko

Department of Architecture, Federal University of Technology, Minna, Niger State, Nigeria

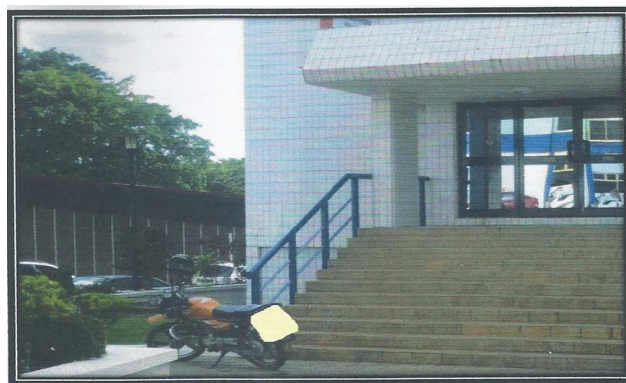
Until the passage of the Disability Law in Nigeria the pursuit of institutional framework for legislation towards the development of facilities to meet the needs of the physically challenged had not been a prime consideration. This is in spite of the fact that the provision of special accesses and rails were made mandatory for all public buildings as part of the law. Consequently, there are physical barriers restricting movement and utilization of public, social and communal facilities. Though there are a number of multi-storey buildings which have incorporated elevators to aid movement from one floor to the other, the entrances have only a flight of stairs thus hindering access from the forecourt to the ground floor as shown in figure 1.

Figure 1. Entrance of a public building with no ramp provided

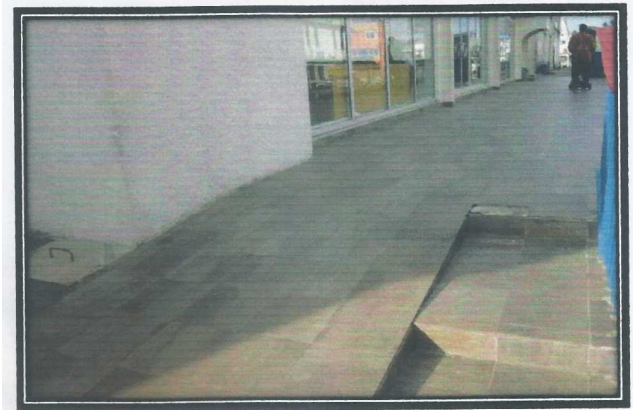
The UN Enable (2004) recommends that ramp surface should be hard and non-slip. Data from the field survey revealed that 60% of the ramps studied had porcelain or ceramic floor tiles finish, 38% had unpolished terrazzo finish, and 2% had cement sand screed finish. Though the use of unpolished tiles provides a firm surface for users, there are some with relatively smooth surfaces while the polished tiles do not provide a non-slip surface for users hence posing a hazard of slipping off, especially in times of rain as most of the ramps are neither covered nor protected. ADA (2002) indicates that, thresholds should not be placed at the doors and that if there is a requirement for making thresholds, then its height should not exceed 25mm. Thresholds obtained from the field ranged between 50mm and 100mm and were not leveled to facilitate passage of wheelchairs. The accessibility of about 80% of buildings with ramps in place is limited due to barriers posed by relatively high thresholds at the doorway. Figures 3 and 5 show the entrance of a public building with a relatively high door threshold that confronts users after ascending a ramp.

Figure 3. High thresholds at a main entrance doorway

- Finished floor levels at entrances should be increased to either remove thresholds or reduce them to the recommended maximum height of 25mm.
- The Ministries, Departments and Agencies responsible for the built environment should initiate measures to remove obstacles to participation in the physical environment by persons with disabilities. Such measures should lead to the development of standards and guidelines and also include enforcing laws to ensure accessibility to various areas in the society, such as housing, commercial buildings, and other outdoor environment,

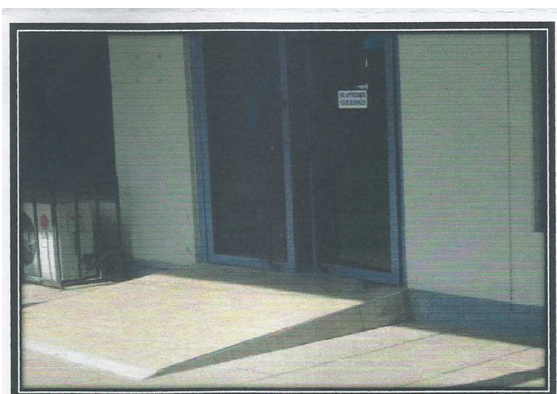
Majority of the landings have the same width as the ramp; however, the lengths are shorter than the recommended size of 1,525mm. Data from the field survey revealed that 25% of the buildings studied had no landing before the entrance as the ramps run directly to the threshold at the door. Even though these ramps did not need to have a landing because the total vertical rise of 440mm was less than the recommended value, the absence of the landing before the door caused wheelchair users and ambulant persons to tip backwards as they stop on the sloping surface of the ramp to open the door (Figure 4).

Figure 4. Ramp running directly to threshold of door with no landing

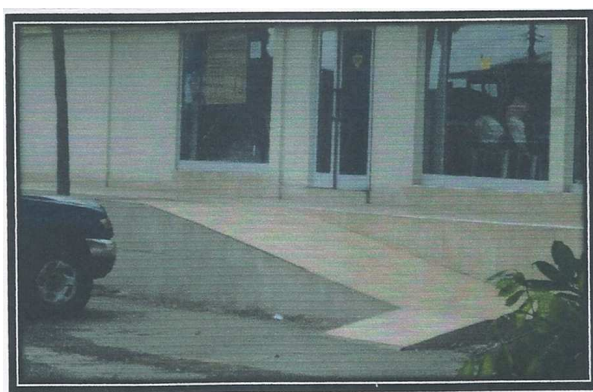
If a ramp has a rise greater than 150mm or a horizontal projection greater than 1,830mm, then it shall have a handrail on both sides (ADA, 2002). The handrails should be firmly fixed with the top properly shaped and placed safely to provide guidance, balance and support to users. About 45% of the ramps surveyed had handrails on either the left or the right side only; with 10% having handrails on both sides of the ramp, and 45% of the ramps had no handrails at all though their vertical rising height is greater than 150mm and the horizontal projection is greater than 1,830mm (Figure 5).

Figure 5. Ramp with no guiding handrails for users

- Existing ramps that have inappropriate slopes, widths and surfaces should be redesigned and reconstructed with appropriate response to spatial constraints to achieve a gradient ratio of 1:12 and provisions must be made for handrails on both sides of the ramp. Non-slip surfaces should be provided for users to achieve a firm grip during the use of the ramps.
